FLOOD PROOFING PERFORMANCE

Successes
&
Failures

**US Army Corps
of Engineers®**

December 1998

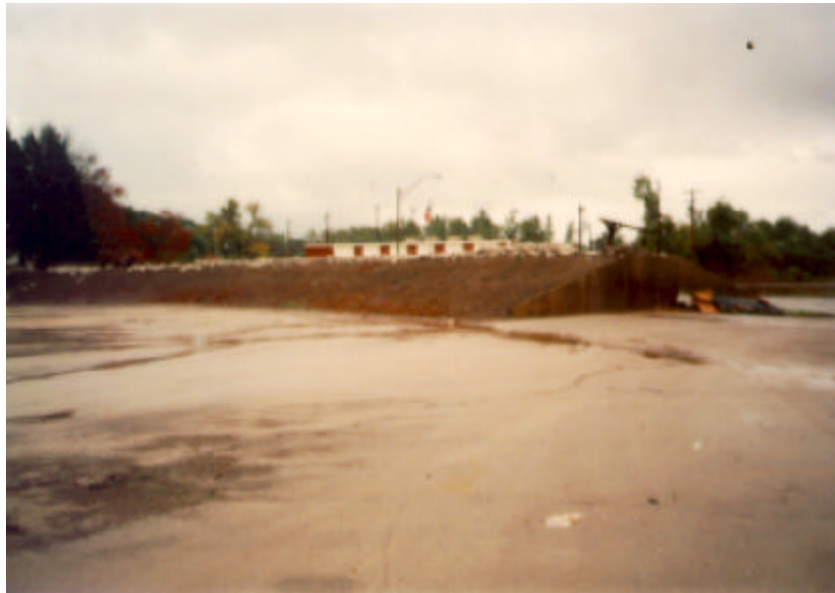
Lesson. In this case, all parts of the flood proofing system functioned as intended except that the levee was overtopped, leading to levee breaching. Obviously, the levee should have been higher for this event. The levee failed where the sideslopes were 1 vertical to 1 horizontal. Levee breaching may not have occurred if flatter sideslopes (1 vertical to 3 horizontal or flatter) had been used. Sideslopes of 1 vertical to 1 horizontal are without question too steep for reliable levee stability. Without levee breaching, a successful flood fight may have been possible. This flood proofing system had a definite weak point -- that portion of the levee with the 1 vertical to 1 horizontal sideslopes. If not enough area was present for a levee with flatter sideslopes, a floodwall should have been built in that location.

Looking at the portion of the partial ring levee with flatter sideslopes. Note the opening that was closed with a closure structure that was successful. Note the sandbag flood fight on top of the levee.

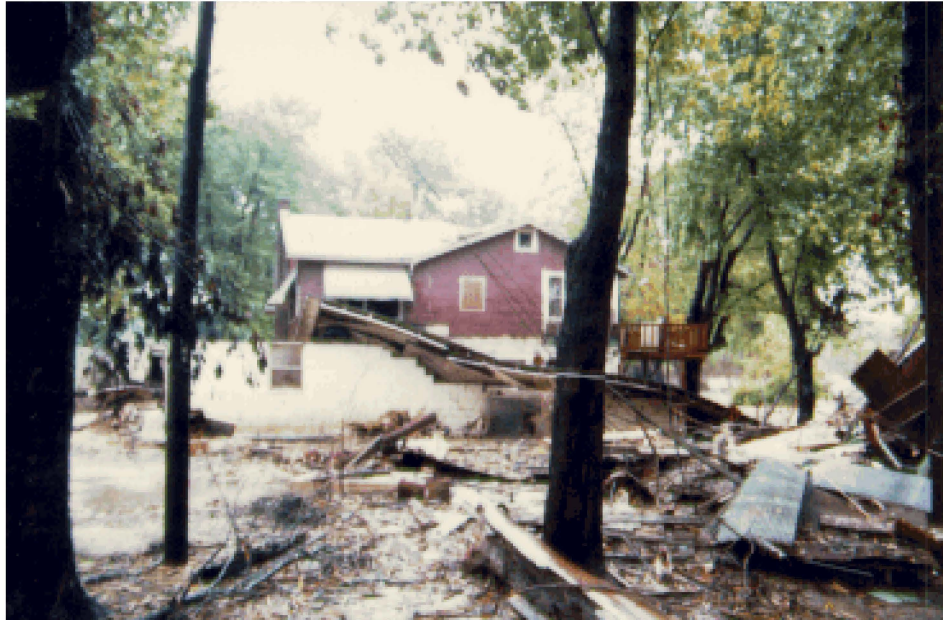
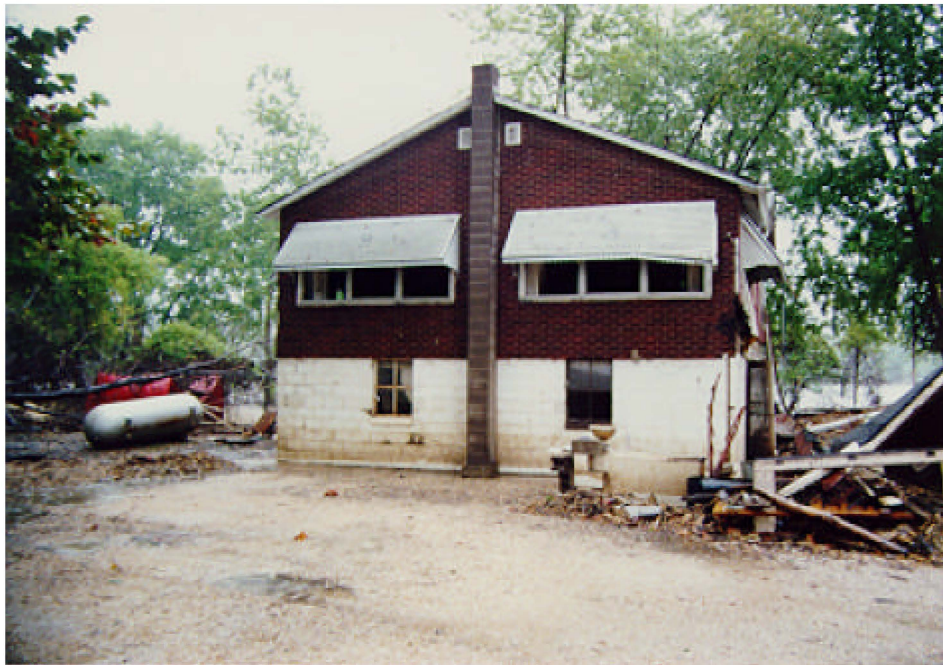
Looking at Structures 52 and 53.

four structures, the extended concrete block wall to support the structure should not have been used in an area close to a major river where high velocity during floodflows could occur. Supports such as columns, posts, or piles embedded sufficiently below grade should have been used, with piles being the preferred choice. Any enclosure of the lower area should have been of minimal strength to easily break under hydodynamic force.

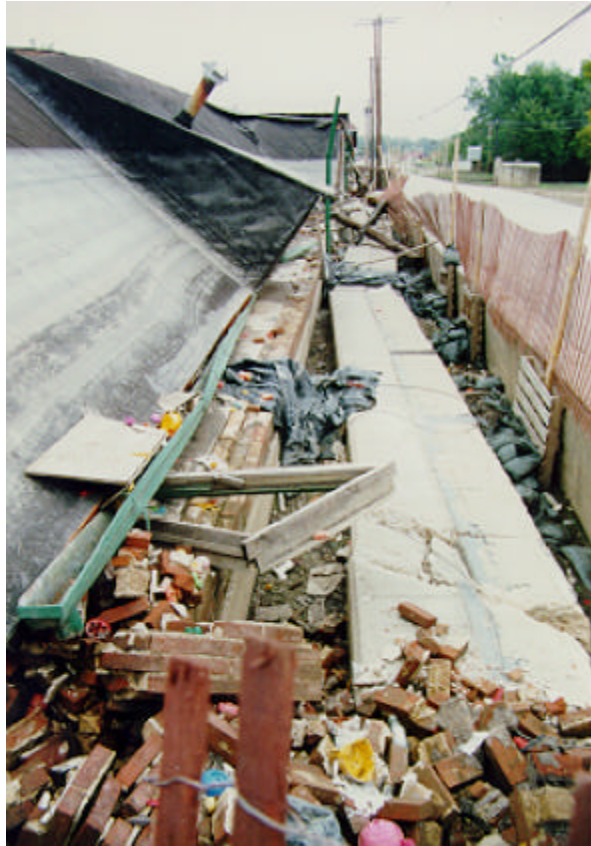
Looking at the collapsed floodwall additions. Note these two additions are still tied together with rebar.

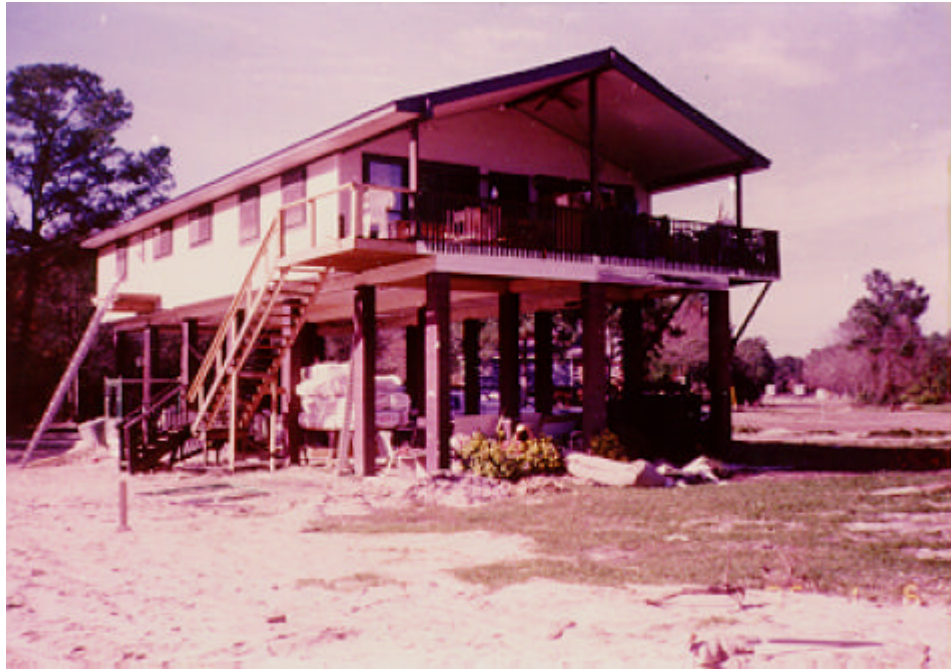
Lesson. This structure received relatively little flood-related damage during this event. The home was realigned and the scoured area filled. Even with this "success," this flood proofing system should not be promoted. The risk to this structure is great for two reasons--both related to debris accumulation. First, severe debris accumulation, coupled with hydrodynamic force, could tip over the structure. Second, scour could severely undermine this structure's foundation because of debris accumulation, also resulting in the structure tipping.

Looking NW at the structure. The San Jacinto River is at far right outside of the photograph.

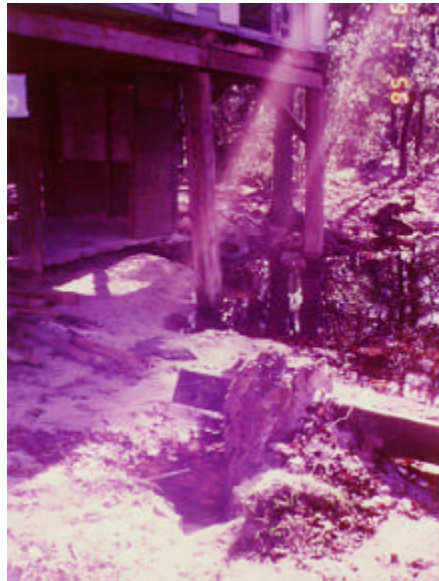
Looking at the structure's shallow post embedment depth.

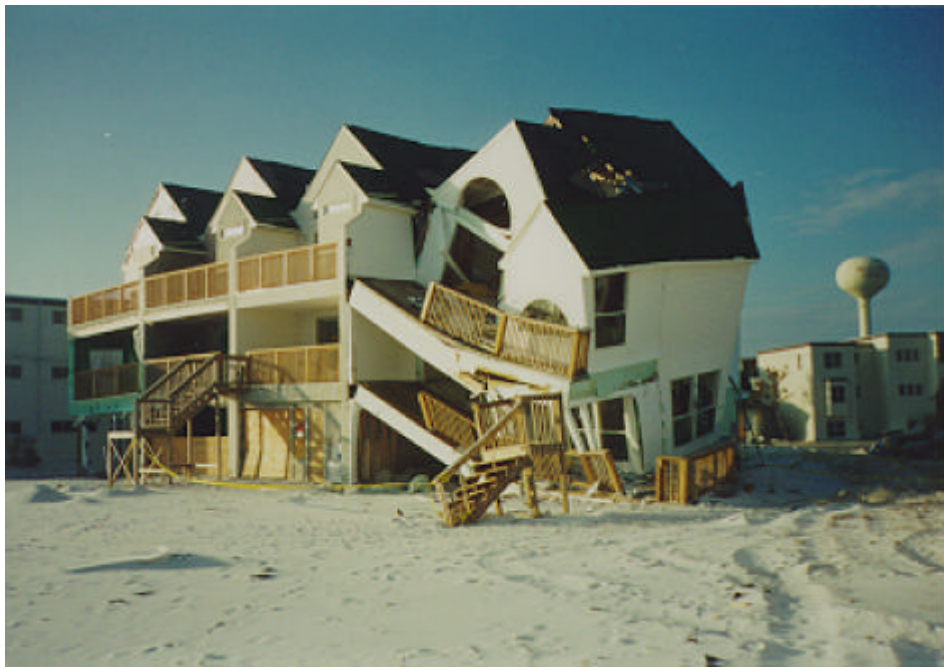
Looking at the structure from the beach.

Lesson. Two basic factors caused the collapse of one-fourth of the structure. First, the construction on the barrier island placed the structure in jeopardy due to high-velocity floodwater, creating both a hydrodynamic force hazard and a scour hazard. Construction in areas such as this should be avoided. Second, the structure foundation that was situated in sand should have been much deeper to resist the forces of erosion caused by the high velocities and compounded by the obstructive nature of the structure.

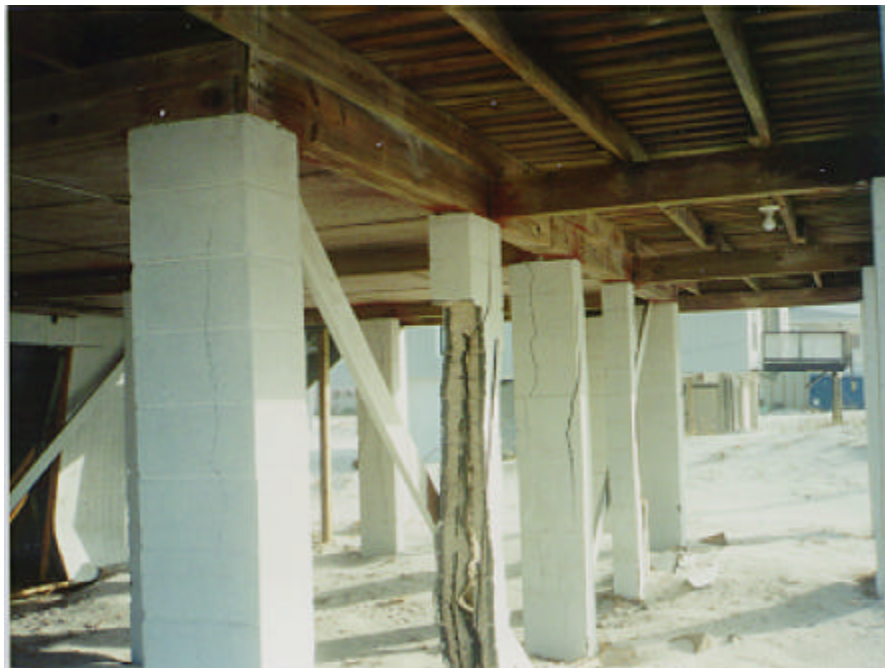
Looking at the column support that was nearing failure.

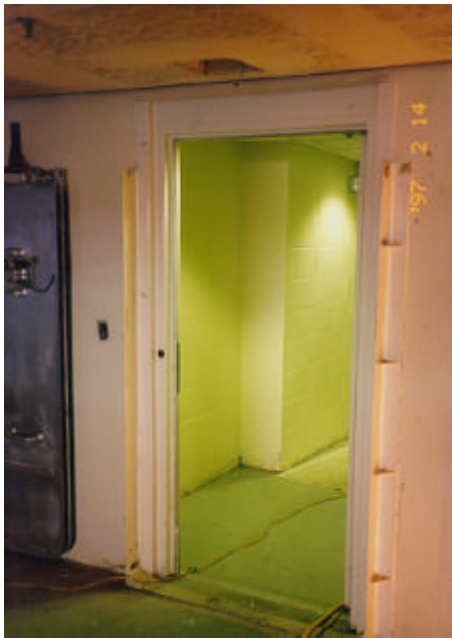
Looking at a doorway into the “protected” area. Note the state-of-the-art pneumatic seal closure at the left in its storage position. Also note the gap between the top of the closure and the top of the doorway.

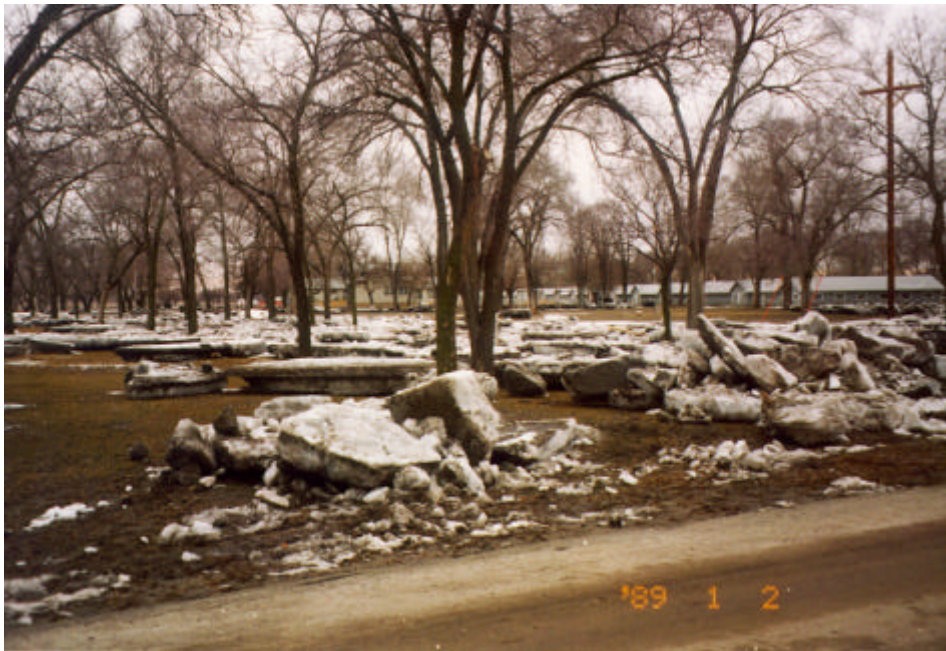
Looking at the massive ice blocks that passed through the area.
